Welch Allyn, Inc.®

DATE: 9/28/07**SAP DIR #: 20010965**

Subject: TSB - CP100-CP200 Drive Gear set screw change**Bulletin Type: Hardware Update****Product Family: CP100 - CP200****Originator: SS / JR Service Engineering Department****Author: Chris Thompson**

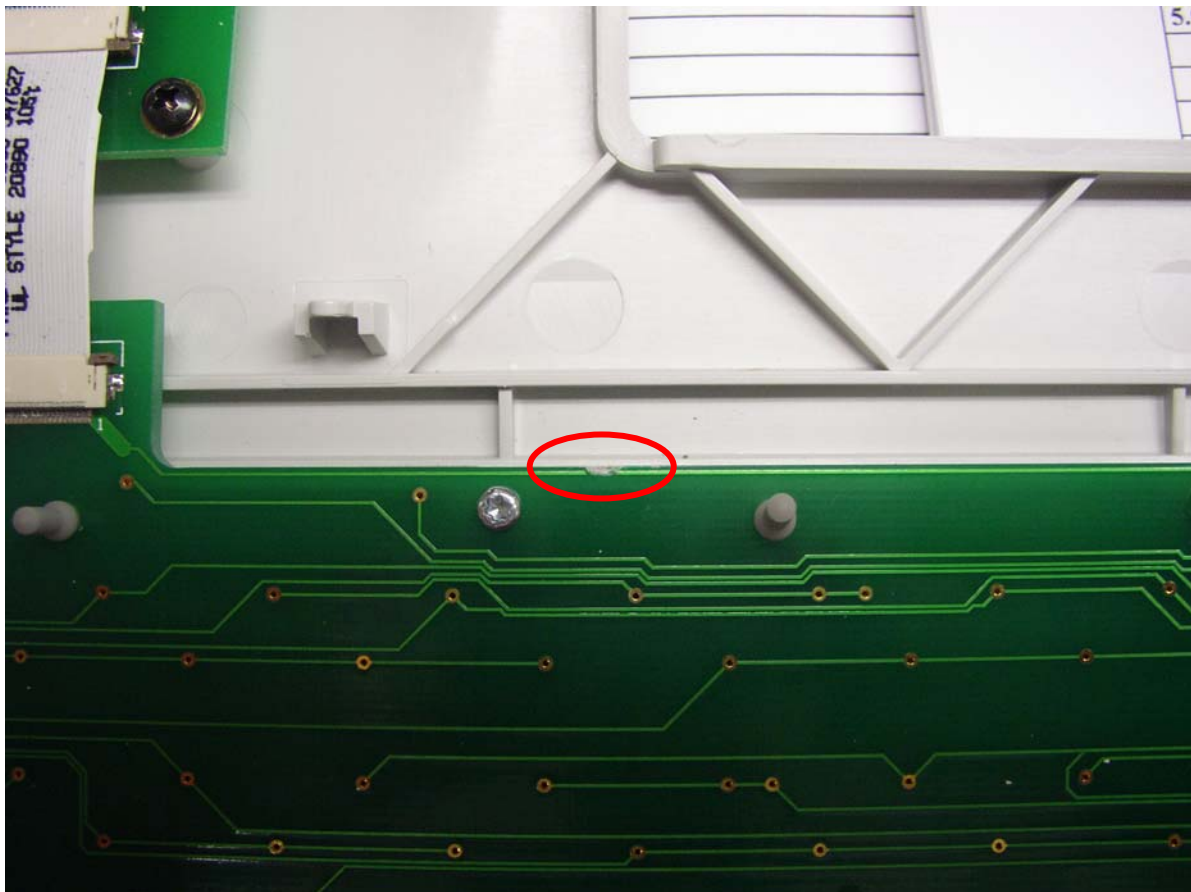
When the drive gear is positioned on the platen roller the long set screw, securing the drive gear, can rub on the bottom of the keyboard PCBA eventually cutting a trace (see image below). The matrix below can assist in diagnoses when speaking with customers.

If one of these is the failure mode of the instrument, a visual inspection of the keyboard will identify if this is the case. Refer to the image below for location of the damage and if identified as the cause, the keyboard and set screw must be replaced.

- If there are signs that the set screw has been rubbing, the keyboard shall be replaced and the set screw for the drive gear replaced with the new shorter set screw (708790).
- If there are no signs of wear then the set screw shall be replaced with the new shorter set screw (708790).
