**DATE: 2008-11-14****SAP DIR #: 20011267**

**Subject: TSB - CP100-CP200 Service Reset****Bulletin Type: Process Change****Product Family: CP100 - CP200****Originator: SS / JR Service Engineering Department****Author: Dave Savarese**

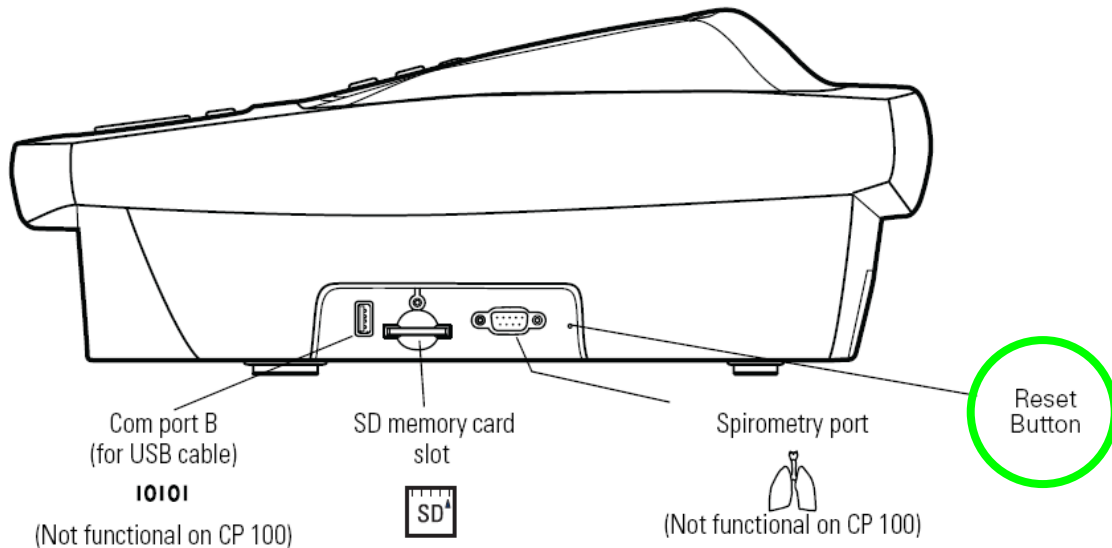
**Issue:** An investigation into CPX00 boot up failures has resulted in added steps to the Service and Repair process to increase the screening for all main PCBAs. Following this process ensures that the unit being repaired and/or tested will be reset or "fully re-booted" a minimum of 3 times as part of the functional testing before the product is shipped. This increases screening for the failure to boot up issue. The 3 boot process must be reflected at all Welch Allyn authorized repair facilities.

- A full re-boot is achieved by connecting AC power to a unit that has a disconnected battery.
- A reset is achieved by pressing the reset button via the unmarked pinhole on the right side of the unit near the lung graphic. See the illustration below.

**Solution Statement:** The above process must be reflected at all Welch Allyn authorized repair facilities as part of the CP100/CP200 functionality check before the unit is returned to the customer. These facilities shall ensure that the unit in for service will be successfully "reset" and/or "fully re-booted" no less than 3 times prior to being to shipping back to the customer. Each reset and/or full re-boot can be considered successful once the operator observes the onscreen prompt to set the date and time. If at any point there is a boot failure indicated by horizontal colored bars displayed and 3 beeps (CP200) or a blank screen and 3 beeps (CP100) the main PCBA shall be replaced.
