**Technical Service Bulletin**

**Date: 2010-09-16**

**Subject:** TSB – CP50 & CP50 Plus V01.00.01 SOFTWARE RELEASE

**Product(s) Referenced:** CP50 and CP50 Plus Electrocardiographs

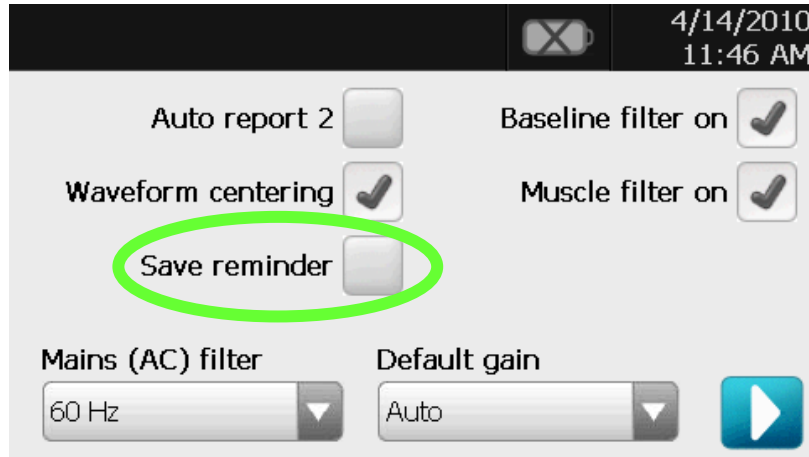
- **Corrected USB to PC connectivity issues when powering from cold boot or returning from standby mode.**
- **ECG “Save Reminder” option added.**  
With the Auto Save feature disabled; when exiting the POST ECG view, the user will have the option be reminded that the ECG test has not been saved and given the option to do so if desired. This option may be enabled or disabled in: *Menu>Settings>ECG Configuration*.

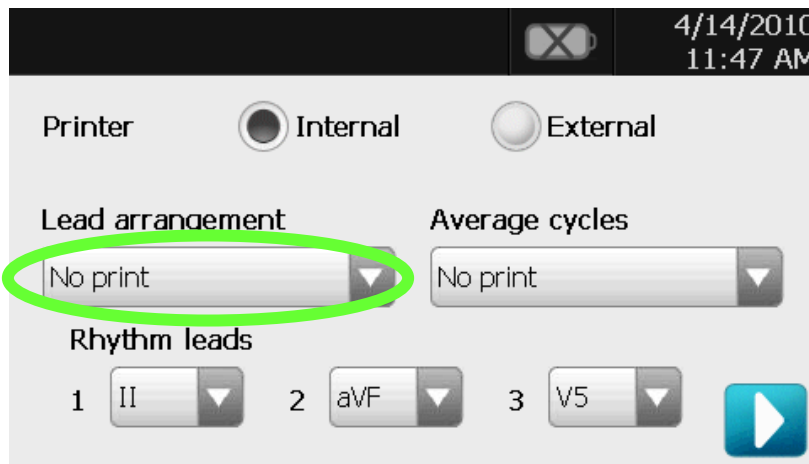
- **“No Print” option added to Auto report 1 and 2 lead arrangement configuration. *Menu>Settings>Auto Report 1 (2)*.**  
When enabled, Auto ECG will proceed from Patient Demographic to Acquisition to Analysis and straight to Post Auto ECG without printing. For STAT Auto ECG, the device will proceed from Acquisition to Analysis and straight to Post Auto ECG without printing if the Auto Report’s Lead configuration is set to “No print”.

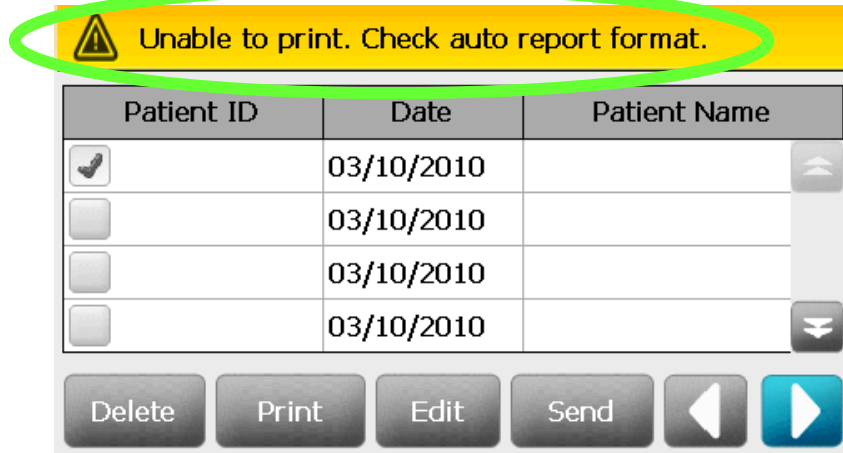
When printing ECG test records from the ECG Test folder, if the selected Auto Report Format's lead configuration is set to "No Print", the device will display "Unable to print. Check auto report format" at the top of the screen.

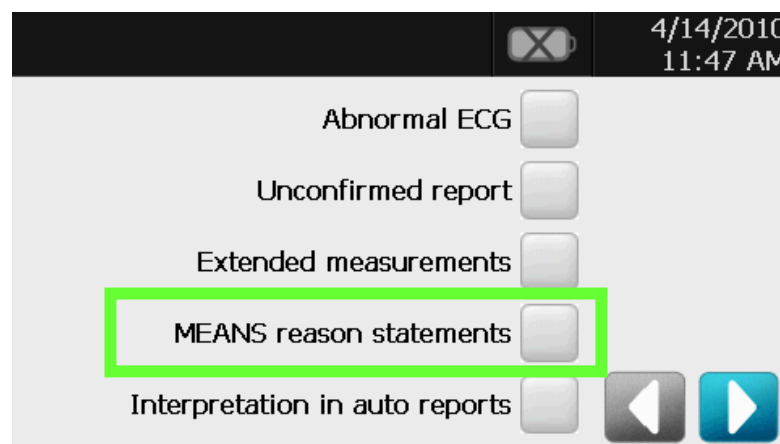
➤ **Option added for turning on/off MEANS reason statements on printout.** This option will be disabled (will not print) by default.

*Menu>Settings>Auto Report 1 (2).*

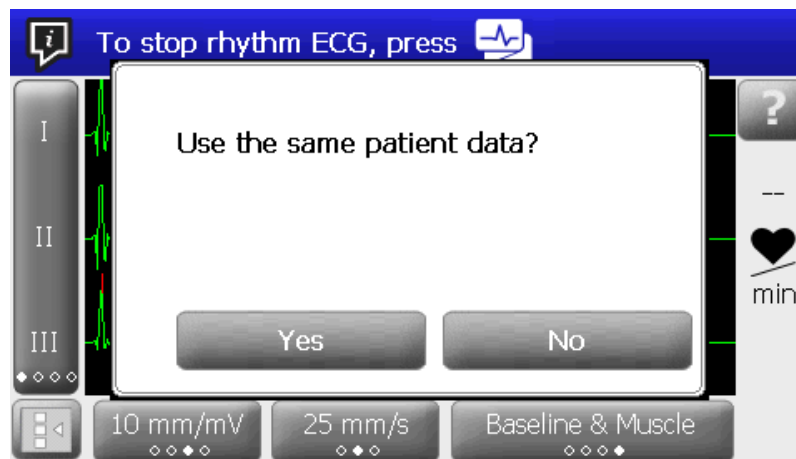
➤ **Additional prompt added to allow users to use the previous patient information for a Rhythm ECG.**

When a Rhythm ECG is started, the user will be prompted whether to reuse the last patient demographic, if available or none if no previous patient information exists. The dialogue "Use the same patient data?" will be displayed.
