**Technical Service
Bulletin**

Cardio Products

Date: 2010-12-10	SAP DIR #: 20012096
Subject:	TSB – CP50 & CP50 Plus V01.10.01 SOFTWARE RELEASE
CAR Number:	N/A
Distribution Scope:	WA Internal WA Technical Support, Product Service, & International Service Centers
Product(s) Referenced:	CP50 and CP50 Plus Electrocardiographs
SW Version:	ALL
Serial No. / Lot Code:	N/A
Summary:	The Welch Allyn Diagnostic Cardiology Team is pleased to announce a new version of software for the CP50 and CP50 Plus electrocardiographs. This version 01.10.01 software is a general maintenance release that incorporates several improvements outlined below. This update incorporates all prior updates.
Issue:	Based on MPD SOP-20211, the software update is classified as continuing engineering project, which is governed by SOP-20213.

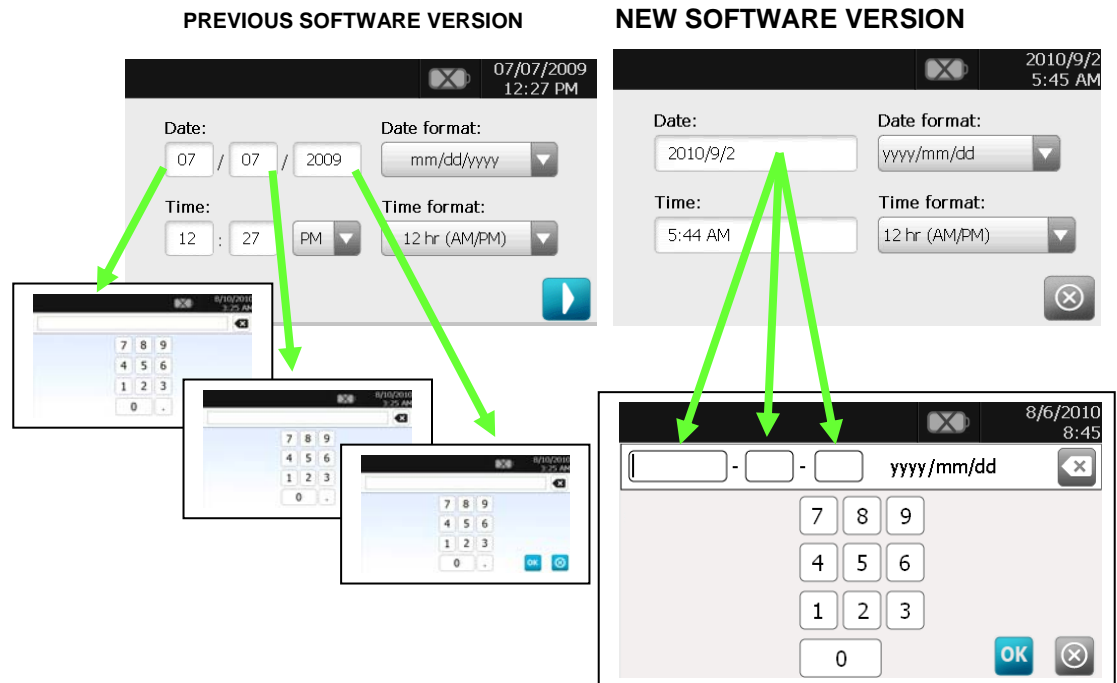
➤ **User interface improvement: Date & Time entry**

During an Auto ECG procedure, the age or date of birth of the patient is requested. Previously, we needed to tap on fields individually such as day, month, and year to enter the date (multiple tapping). The improved interface will allow for these fields to be filled from a single screen. This change applies to the system's regional date settings as well. Similarly, the clock setting will allow the hour and minute fields to be filled from a single screen. Samples of the new user interface are shown in the images below.
