<b>Document Description:</b> TSB - Upgrade Masimo License	<b>Document Number:</b> 20012516 <b>Version:</b> D

## *Technical Service Bulletin*

<b>Product:</b>	CVSM, CIWS	<b>Date:</b>	2017-07-27
<b>Subject:</b>	TSB - Upgrade Masimo License		
<b>HW Version(s) Affected:</b>	All models with Masimo SpO2	<b>SW Version(s) Affected:</b>	1.70.00 or later
<b>Serial Numbers Affected:</b>	NA	<b>Lot or Date Code Affected:</b>	NA

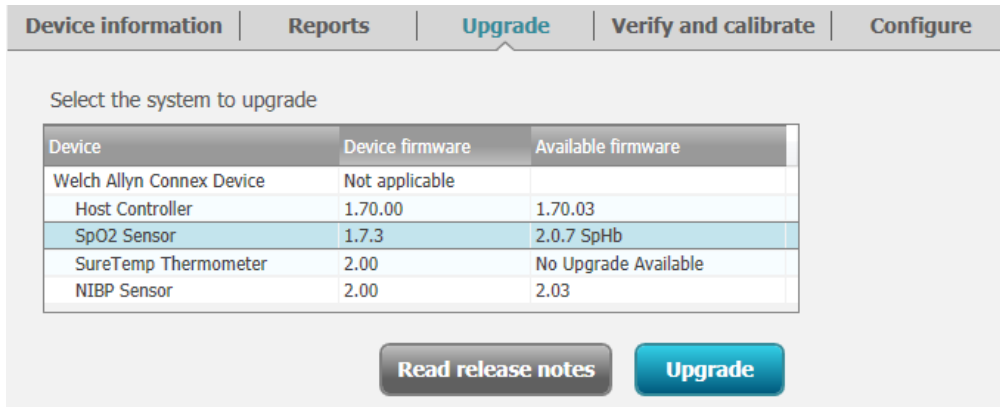
- 10.1. The service tool upgrade tab will show an upgrade available for the SpO2 sensor:

- 10.2. To perform the upgrade, the customer will select the **Welch Allyn Connex Device** row and click the **Upgrade all** button (WAST 1.6.0.0 and above), or select the **SpO2 Sensor** row and click the upgrade button (WAST 1.5.0.2 or below).

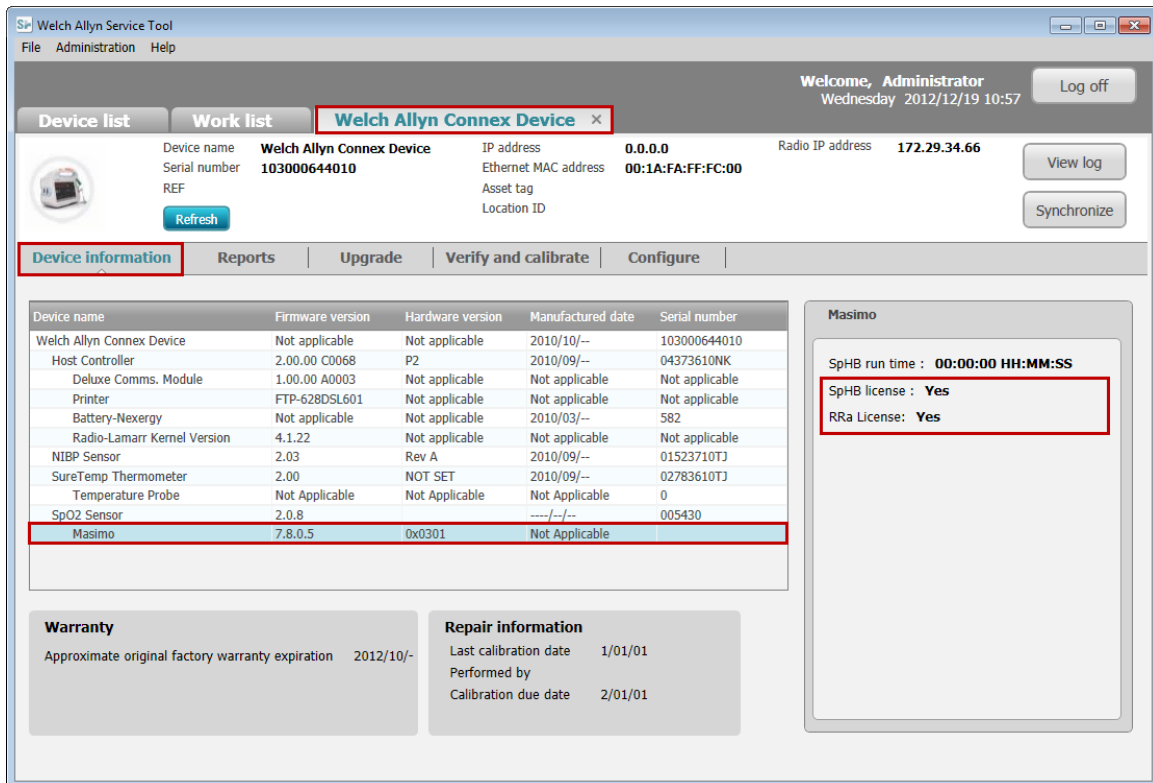
10.3. After the customer performs the upgrade, they can confirm the upgrade was successful by attaching the applicable sensor or checking SpO2 license in the WAST as shown below:
