**Technical Service Bulletin**

**Cardio Products**

**Subject:** 20013220A TSB-CP100\_200 LI-ION BATTERY, 2.6 SW

**Product(s) Referenced:** CP100 & CP200 Electrocardiographs  
Li-Ion Battery, 2.6 SW Upgrade Kit P/N: 105204

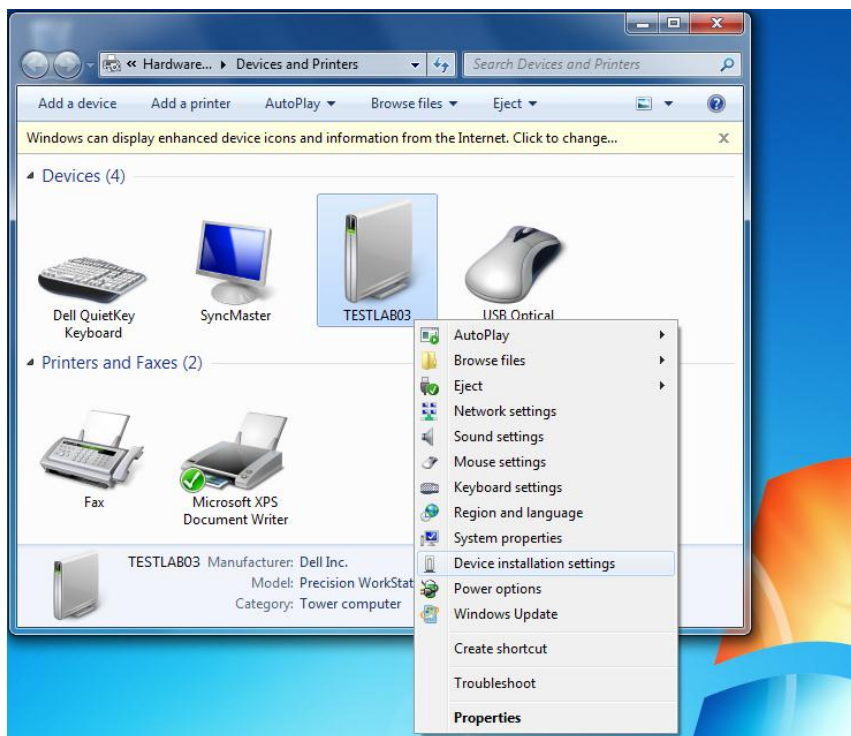
- 1) Disconnect CP200 from PC
- 2) In Start menu, select the Devices and Printers.
- 3) On pop up window, right click the icon with the computer name. On the popup menu, select Device installation settings. Example shows computer name of TESTLAB03.

- 4) On Device Installation Settings window, choose- Yes, do this automatically.
- 5) Click on Save Changes.
- 6) Reconnect CP200 to PC

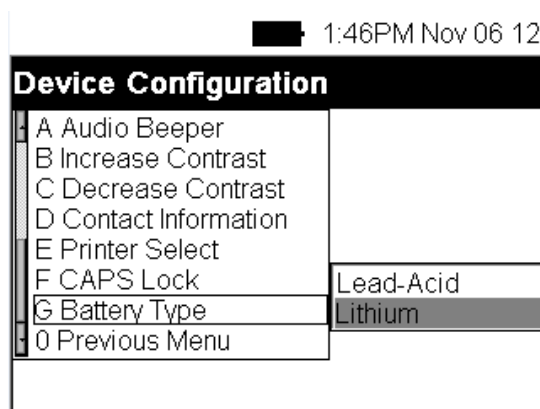
- CP-100 Menu:
  1. Press the Menu button
  2. Press “2” for System Settings
  3. Press “1” for Device Configuration
  4. Press “G” for Battery Type
    - NOTE: Example shows software install default choice of Lithium.

Support for the Li-Ion battery is set by default with the installation of the 2.6 software. If the software is installed into a device that has a Sealed Lead Acid (SLA) battery installed, the battery type will need to be changed manually so that the battery type is correctly selected in the device menu. The software also provides a more accurately displayed battery capacity gauge for the SLA than previous software versions.

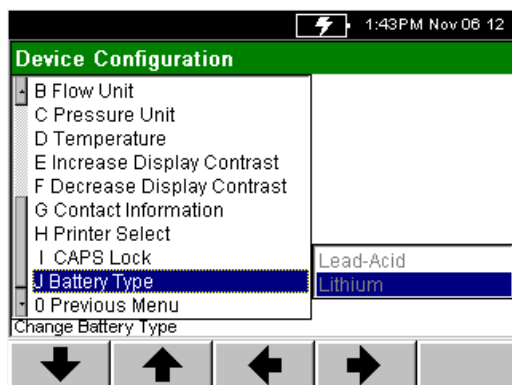
- CP-200 Menu:
  1. Press the Menu button
  2. Press “5” for System Settings
  3. Press “1” for Device Configuration
  4. Press “J” for Battery Type
    - NOTE: Example shows software install default choice of Lithium.

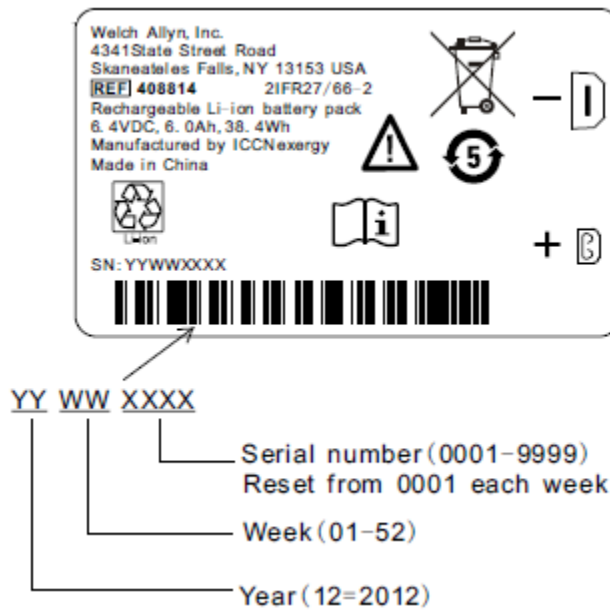
Note: The age of the battery may be determined using the serial number printed on the battery label as shown below. In certain cases, an invoice may be requested from the customer to confirm warranty status.
