**Technical Service Bulletin**

**PATIENT MONITORS**

<b>Subject:</b>	TSB-LXi HANDLE HOUSING SCREW REPLACEMENT
<b>Distribution Scope:</b>	Welch Allyn Global Technical Support, Product, Field & Customer Service Teams, & WA ASP's.
<b>Product(s) Referenced:</b>	All SPOT 4500 LXIs 421037 / SCR,4-20X.31 PLASTITE PH TORX (SHORT) 713015 / SCREW, PLASTITE #4-20 X .500 PAN HEAD (LONG) 700103 / HSG, REAR, ULTRA 700101 / HSG, HANDLE, ULTRA
<b>Summary:</b>	Welch Allyn manufacturing is lengthening the screws used to fasten the rear housing (700103) to the handle housing (700101) to address the occurrence of the shorter plastite (self-tapping) screws (421037) stripping out the screw bosses of the handle housing.
<b>Issue:</b>	The shorter screws that were used to attach the rear housing to the handle housing have been found to strip out the screw bosses of the handle housing.

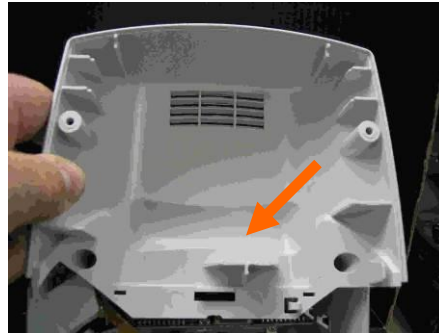
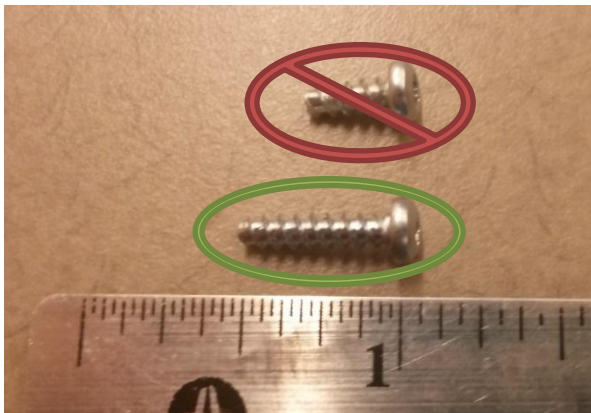
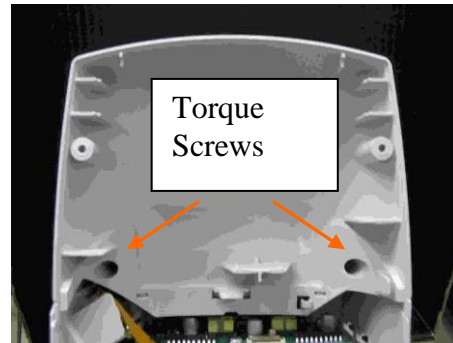
Use 713015 (longer) screw!

If, during a repair, it is necessary to reassemble the rear housing to the handle housing, attach the rear housing (700103) onto the handle housing (700101) using two **long** screws (713015). Torque to 3.75 +/- .4 inch lbs.
