Technical Service Bulletin

Date: 2014-12-19

Subject:	TSB-PROLINK_PC COMPATIBILITY ISSUE
Distribution Scope:	Welch Allyn Global Technical Support, Product, Field & Customer Service Teams, WA ASP's
Product(s) Referenced:	<ul style="list-style-type: none"> • PRO-60023 / PROLINK USB CBL ASSY (2M) • PRO-60024 / PROLINK USB CBL ASSY (3M) • PRO-60025 / PROLINK USB CBL ASSY (5M) <p>All CPWS 1.6.X Resting and Stress configurations.</p>
Serial No.:	<p>Range of PROlink serial numbers affected:</p> <ul style="list-style-type: none"> • 201310XXXXX through 201411XXXXX (see exemption tables in the Action section)
Summary:	Affected PROlink cables may not install properly onto certain PCs. In some instances, the cable may install but cause issues during the viewing and/ or recording process in CPWS. This TSB communicates the recognition of, and the solution to, these issues.
Issue:	<p>It has been determined that the PROlink cables manufactured from October 1, 2013 through November 2014 may fail to go through the full USB enumeration process on certain PCs. The net effect is that, after the cable is plugged in, nothing happens and the PROlink device will not show up in the system's Device Manager

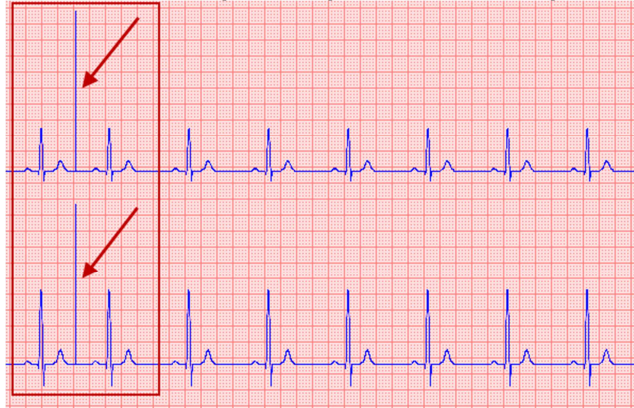
On other systems, a few of these cables appear to function normally but may cause occasional framing errors and/or create “spikes”, during the ECG recording. When monitoring the ECG, framing errors may be counted in the status bar of the recording window. During recording, the ECG acquisition may reset to 0 (zero) one or more times before completing.

- Example of “spike” during viewing and/or recording:

Action: Customers experiencing any of the issues detailed above while using PROlink cables labeled with serial numbers in the defined range will have their PROlink cables replaced free of charge, regardless of warranty or PIC coverage status.
