Document Description: TSB-CP150 V2.00.06 SOFTWARE RELEASE	Document Number: 20014125 Version: A

Technical Service Bulletin

Product: CP150 Electrocardiograph **Date:** 2015-12-27

Subject: CP150 2.00.06 Software Update – Save to Network Location & Rhythm Print Stutter Solutions

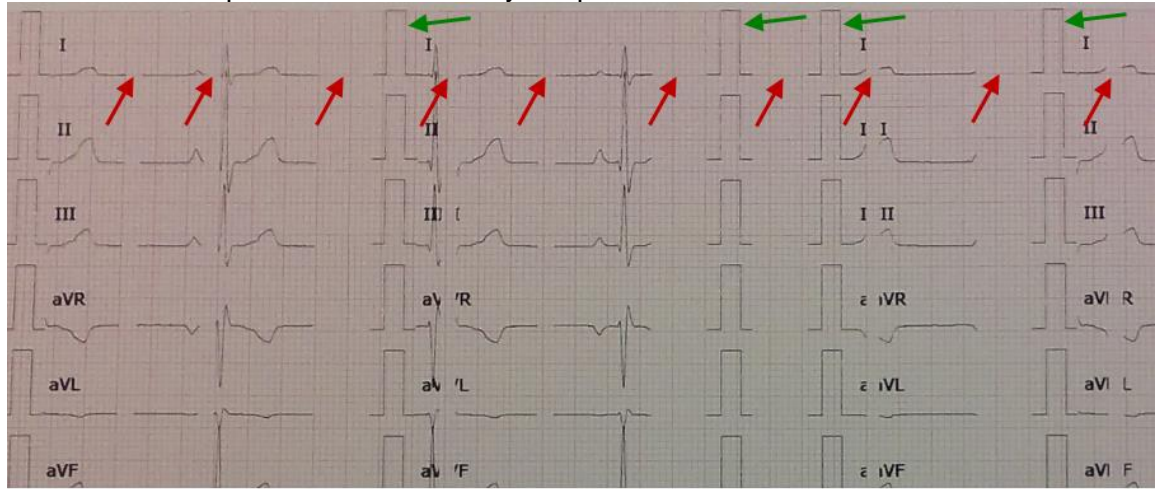
An example of the affected Rhythm printout is shown below:

← = Calibration Pulse / Restart of Rhythm Print

↗ = Gap in data

NOTE: This issue does not occur on firmware versions prior to 2.00.05.

Provide the 2.00.06 update for devices exhibiting either, or both, of these issues. The update will be deployed to customers via PartnerConnect and the Welch Allyn Service Tool. Deploy Software Package **CP150_2.00.06**:
