| Document Description: TSB-Braun 6000 Broken Tether | Document Number: 20015238 Version: A |

Technical Service Bulletin

| Product: Braun 6000 | Date: 2019-01-11 |
| Subject: TSB-Braun 6000 Broken Tethers | |

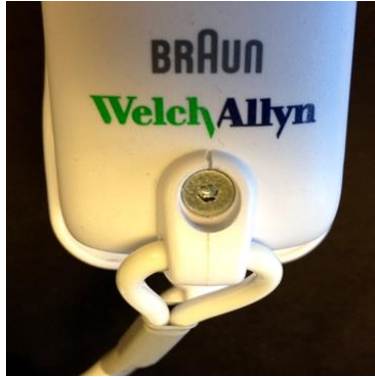
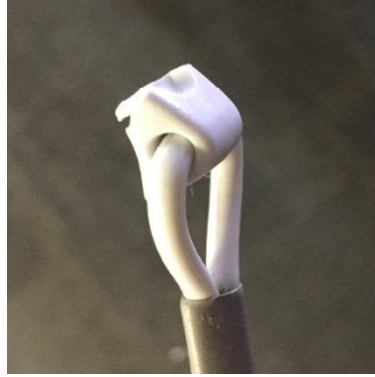
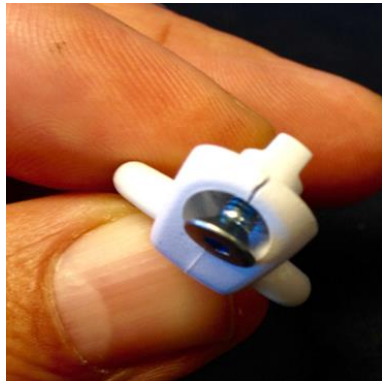
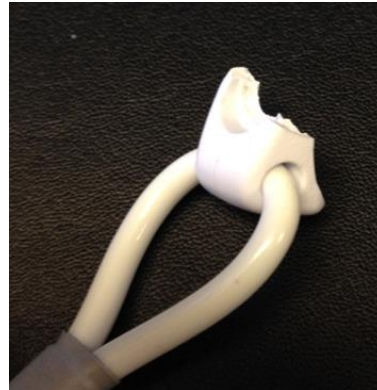
| Issue: | The cleat securing the tether to the handle is cracking and/or breaking resulting in the handle becoming untethered from the cradle or CSM. The cleat may crack and/or break due to over tightening of the screw securing the cleat to the thermometer. The problem may be aggravated when using unauthorized cleaning solutions which can cause the plastic to become brittle. |

Photos: Cleat securing tether to handle may crack and result in tether becoming detached from the handle.

| Action: | <ul style="list-style-type: none"> • Recommended torque specification to secure the cleat to the handle is 6.0in-lbs. • Use only approved cleaning solutions in accordance with the DFU. • The tether is covered by a one-year warranty. Tethers with broken cleats will be replaced at no charge under the warranty. |
