Document Description: TSB-Braun 6000 SW v.3.98 Release	Document Number: 20014095 Version: A

Technical Service Bulletin

Product:	Braun 6000 Pro Thermoscan Thermometer	Date:	2015-11-10
Subject:	TSB-Braun 6000 SW v.3.98 Release		
HW Version(s) Affected:	2.2	SW Version(s) Affected:	3.85, 3.75
Serial Numbers Affected:	NA	Lot or Date Code Affected:	NA
Classification:	As Needed		
Distribution:	<input checked="" type="checkbox"/> Customer Care <input checked="" type="checkbox"/> Product Service <input type="checkbox"/> Field Service <input type="checkbox"/> ASPs <input type="checkbox"/> Distributors <input type="checkbox"/> Customers <input checked="" type="checkbox"/> Company Confidential		
<u>THIS DOCUMENT CONTAINS CONFIDENTIAL INFORMATION</u>			
It can be distributed or made available to only those individuals, companies, and organizations which have current Welch Allyn Confidentiality Agreements, and have a need to know.			
Training Required:	<input checked="" type="checkbox"/> Yes <input type="checkbox"/> No		
Summary:	Software version 3.98 is released for Braun 6000 thermometers to address issues found in released software versions 3.85 and 3.75.

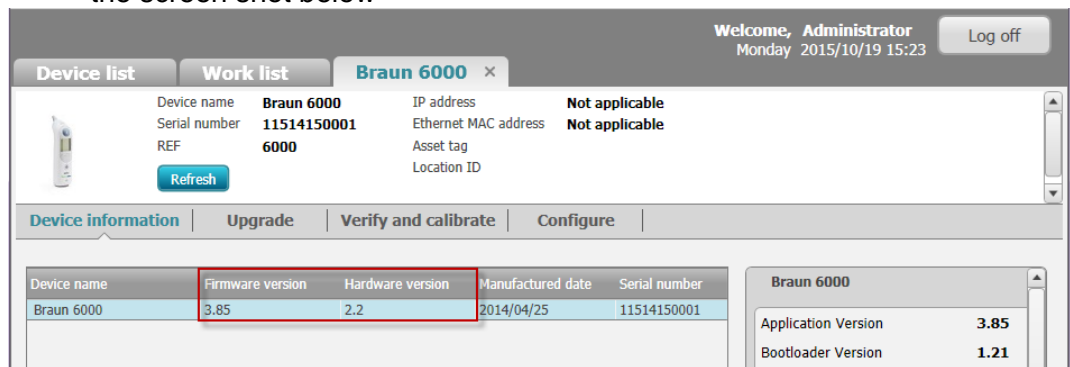
1. Launch the service tool
2. Log in as ADMIN no password or use preconfigured account
3. Select the Braun 6000 from the Device list
4. The device information tab opens
5. Read the firmware and hardware versions in the Braun 6000 row as shown in the screen shot below
