Technical Service Bulletin

Monitoring Products

- Subject:** TSB - CVSM_CIWS, 1.70.04, Update
- Distribution Scope:** WA ASP's and Distributors
WA Technical Support, Product Service, & International Service Centers
- Product(s) Referenced:** CVSM (Connex Vital Signs Monitor) - All Models
CIWS (Connex Integrated Wall System) - All Models
- SW Version:** CVSM/CIWS Host SW version 1.70.03 and earlier
Note: This release does not support using patient query with Connex VM version 1.x. Connex VM 1.x customers using patient query will need to upgrade to Connex VM 2.0 before installing this update.
- Serial No. / Lot Code:** All
- Summary:** CVSM/CIWS host software version 1.70.04, has been released to resolve initial power up NIBP start button functional issues, and "NIBP not functional. Call for service." Error message due to a kinked or pinched hose.

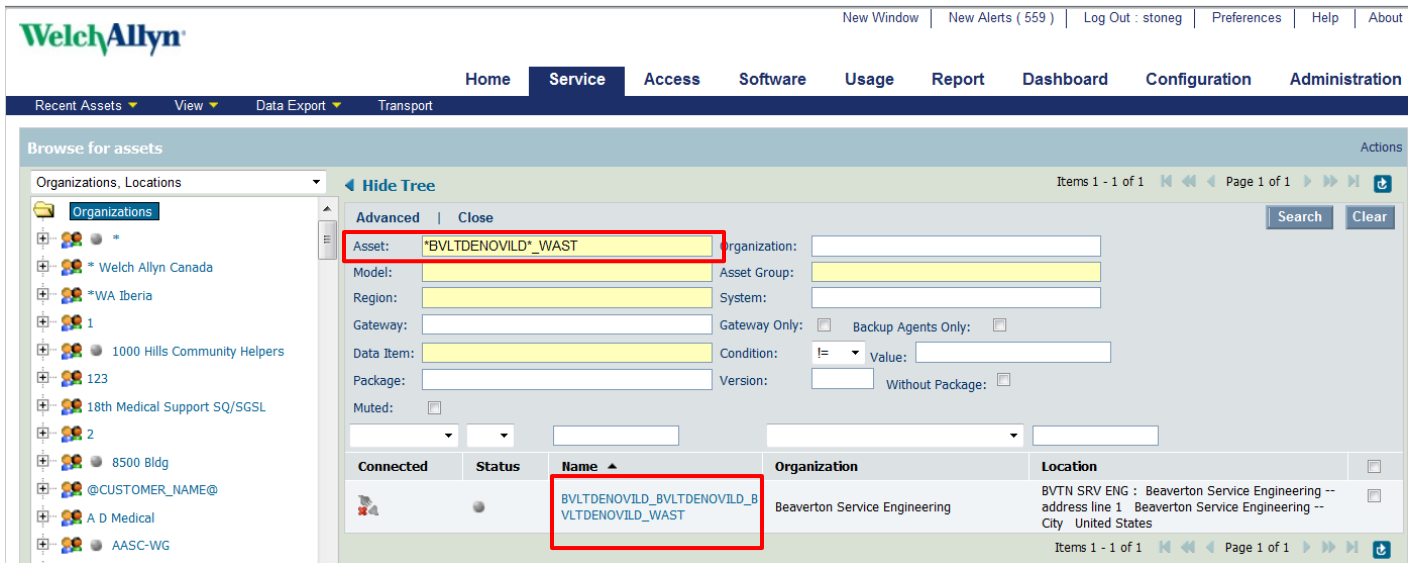
1. Log on to PartnerConnect: <https://welchallynsolutions.com>
2. Go to the Service tab.
3. In the asset field enter the customer’s computer name or registered serial number enclosed with asterisks, followed by “_WAST”, click **Search**.
4. Select the customer’s computer by clicking on the customers computer name in the list, with the “_WAST” ending, to open the WA ServiceTool dashboard screen.
