Technical Service Bulletin

Subject: TSB - CVSM_CIWS, 1.71.02, Release

Product(s) Referenced: CVSM (Connex Vital Signs Monitor) - All Models
CIWS (Connex Integrated Wall System) - All Models

SW Version: Applies to CVSM/CIWS with Host SW version 1.70.04 and earlier

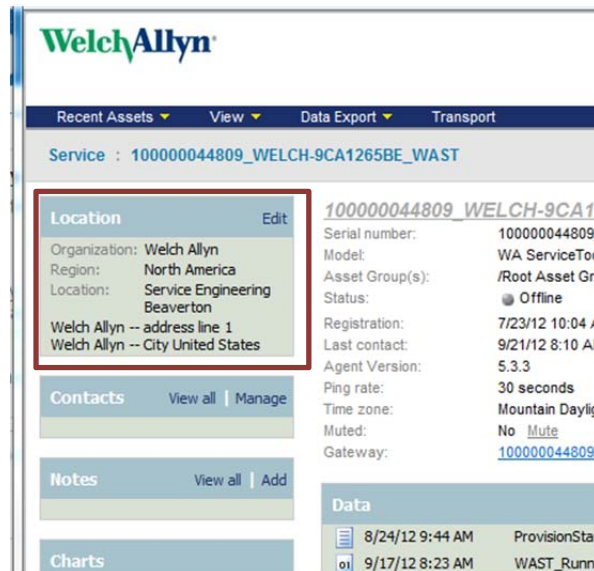
4. Select the customer's computer by clicking on the customer's computer name in the list, with the "_WAST" ending, to open the WA ServiceTool dashboard screen.
5. For customers requesting the Office Profile license, confirm the computer's registered location is in the United States or Canada by checking the Location pane in the upper left hand corner of the dashboard screen. **The Office Profile license may only be sent to computer's registered as being located in the United States or Canada.** If the location is not within the United States or Canada confirm the customer's information with Customer Care.

On the right side of the dashboard, in the actions pane, select, **"Download Office Profile Authorization Code"**.

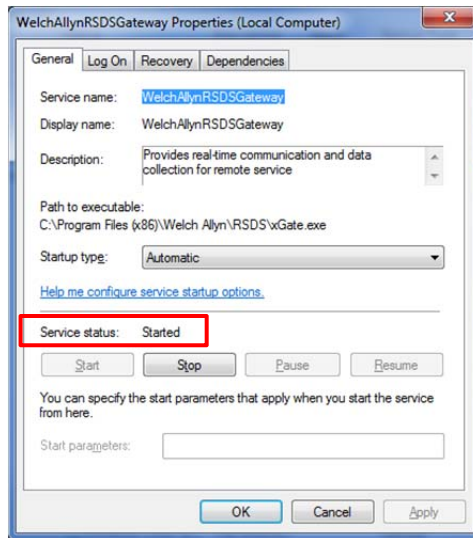
1. Open Administrative tools
2. From the list of administrative tools select Services
3. From the list of services select WelchAllyn RSDS Gateway
4. From the WelchAllyn RSDS Gateway properties dialog box stop the service and restart the service.

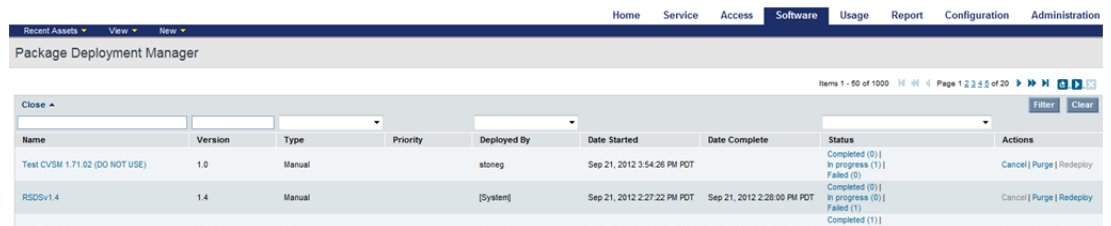
2. Select: View packages that are deployed or in progress
3. Filter by your name in the deployed column to see the packages deployed under your account

4. Observe the status in the second column from the right
5. If the status is "Failed". Return to the WAST dashboard and restart the Action.
6. If the status is "In progress" wait up to 30 minutes for the download to complete, before canceling the download and reinitiating the download from the WAST dash board.
