Technical Service Bulletin

Subject: TSB – CVSM/CIWS, DOWNGRADE HOST SOFTWARE

Product(s) Referenced: CVSM (Connex Vital Signs Monitor)
CIWS (Connex Integrated Wall System)

Summary: This TSB describes how to downgrade the host software on the CVSM or CIWS from versions 2.20.xx to 1.71.03, 1.71.03 to 1.71.02 or 1.71.xx to 1.70.04

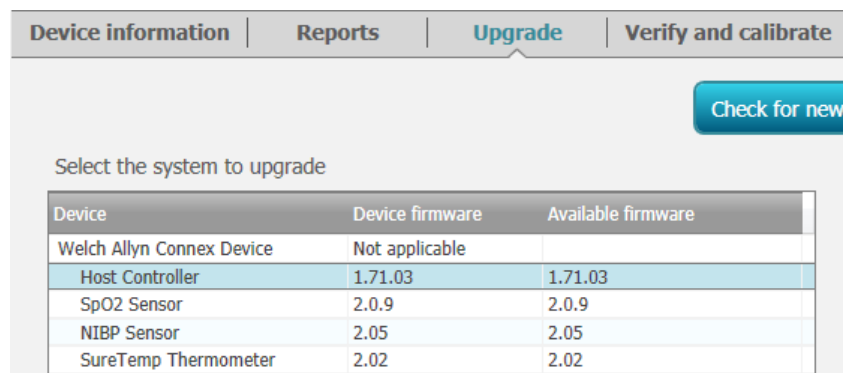
1. Using PartnerConnect, deploy the 1.71.03, 171.02 or 1.70.04 software package to the PC running the WAST per the applicable software release TSB.
2. If assisting a customer remotely, establish a remote desktop session with the customer's PC.
3. Open the WAST and log in using the WelchAllyn super-user account.
4. Select the device to be downgraded in the Device List, and open the device tab.
5. Navigate to the Upgrade tab. The WAST will display the highest version of available host software in the *Host Controller* line.

Device	Device firmware	Available firmware
Welch Allyn Connex Device	Not applicable	
Host Controller	1.71.03	1.71.03
SpO2 Sensor	2.0.9	2.0.9
NIBP Sensor	2.05	2.05
SureTemp Thermometer	2.02	2.02

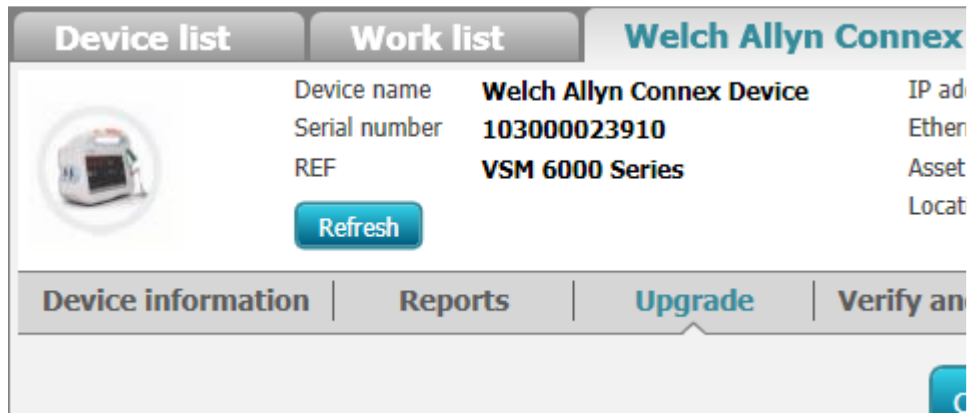
Click Refresh in the WAST to update the *Available Firmware* column.

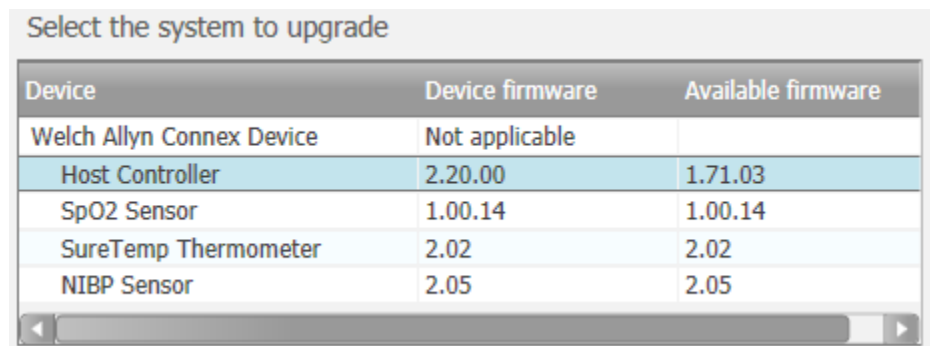
1. If version 1.71.03 is displayed in the *Available Firmware* column, highlight the *Host Controller* line and click Upgrade. Click Yes when prompted to continue.

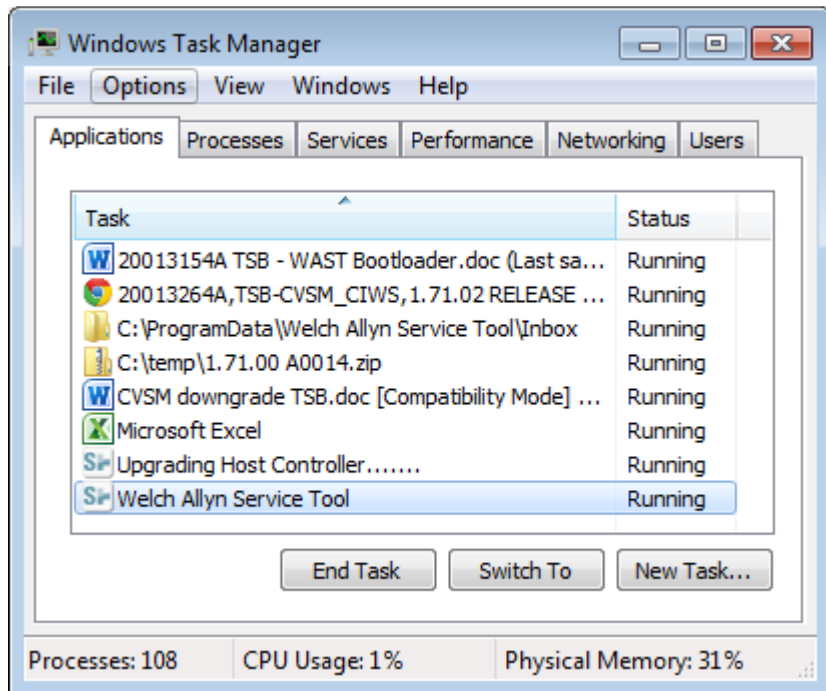
2. When the upgrade process reaches 49%, the device will reboot and display the Welch Allyn splash screen, and the WAST upgrade will remain at 49% indefinitely. When this occurs, press Ctrl+Alt+Delete and open the Windows Task Manager.
3. Select Welch Allyn Service Tool and click End Task. If prompted, select End Now. Clear any pop-up messages that occur.

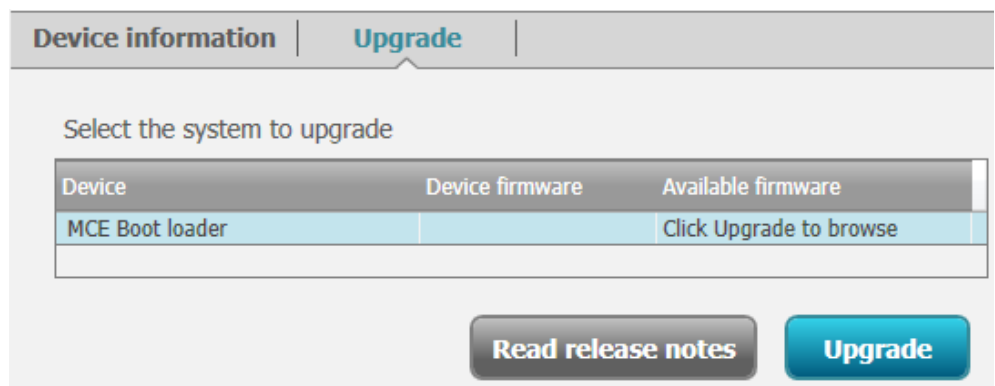
4. Open the WAST and log in using the WelchAllyn super-user account.
5. Select the MCE Boot loader device from the Device List and open the device tab.
6. Navigate to the Upgrade tab, select the MCE Boot loader, and click Upgrade. Click Yes when prompted to continue.

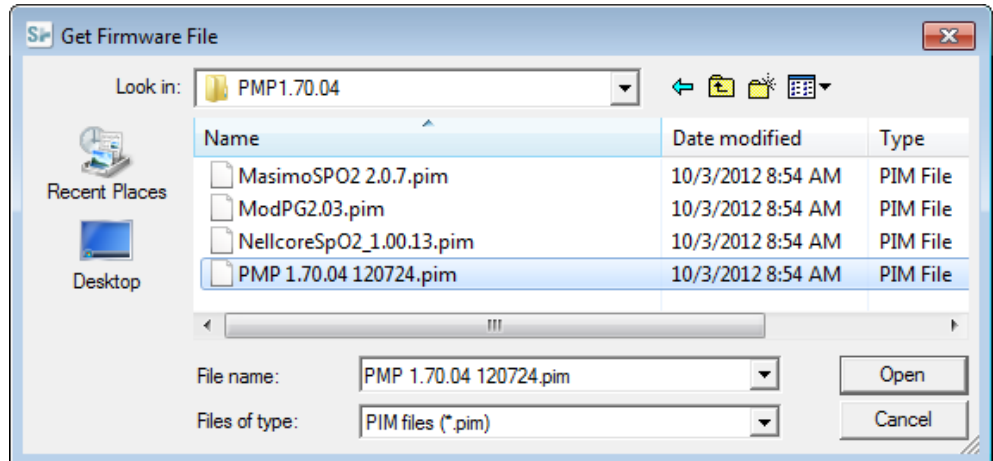
7. In the file browser, select the 1.70.04 firmware image file:
PMP 1.70.04 120724.PIM
and click Open. See the section titled “*Locating the 1.70.04 firmware image*” at the end of this document for paths to the firmware image file in

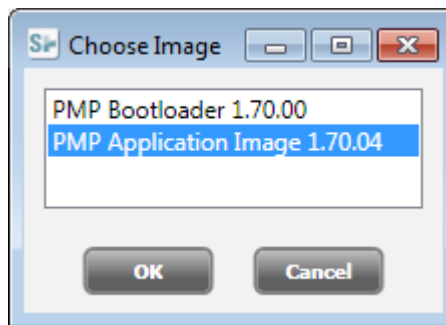
8. Select the Application Image and click OK. The WAST will now complete the software downgrade.
