Technical Service Bulletin

PATIENT MONITORS SYS

- Subject:** TSB-CVSM/CIWS 1.71.03 RELEASE
- Distribution Scope:** Welch Allyn Global Technical Support, Product, Field & Customer Service. WA ASP's and Distributors

- Product(s) Referenced:** CVSM (Connex Vital Signs Monitor) – Models 6300, 6400, 6500
CIWS (Connex Integrated Wall System) - All Models
- Summary:** CVSM/CIWS host software version 1.71.03 and updated FSS module software has been released to improve device stability. This release contains the following improvements and feature enhancements:

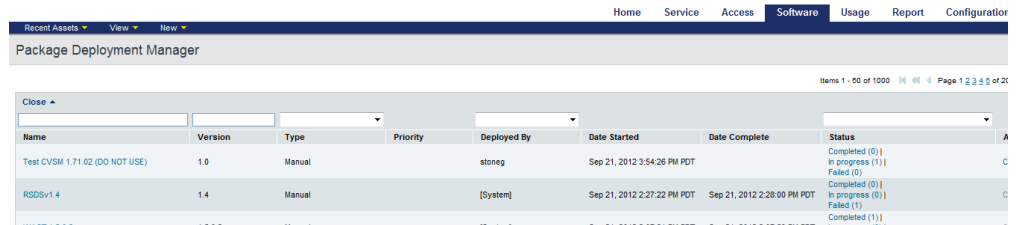
2. Select: View packages that are deployed or in progress
3. Filter by your name in the deployed column to see the packages deployed under your account

4. Observe the status in the second column from the right
5. If the status is "Failed". Return to the WAST dashboard and restart the Action.
