**Technical Service Bulletin**

**Subject:** TSB-CP150 V1.00.03 SOFTWARE RELEASE

**Summary:**  
The Welch Allyn Diagnostic Cardiology Team is releasing an updated version (V1.00.03) of software for CP150 electrocardiographs sold in Singapore and China. This update is also applicable in the ROW for customers whose devices do not incorporate Spirometry functionality.  
This version is a general maintenance release that incorporates updates to version V1.00.01 to address issues gathered from customer reports in the field.  
The specific issues are mentioned below.

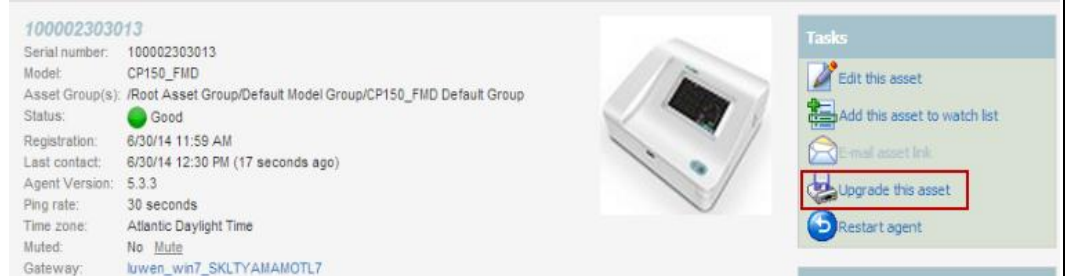
4. Select the device by clicking on the device name in the list, to open the device dashboard screen.
5. Select “Upgrade this asset” on the right side of the dashboard.

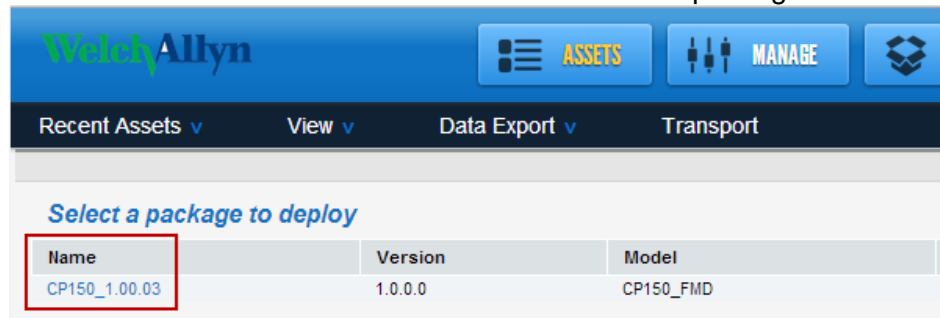
6. Select “CP150V1.00.03” from the list of available packages.
